A MOVEMENT STUDY OF BLACK BEARS
IN THE VICINITY OF A WIND TURBINE PROJECT

SEARSBURG, VERMONT

Prepared For:
GREEN MOUNTAIN POWER CORPORATION
SOUTH BURLINGTON, VERMONT

Submitted:
September 25, 1998

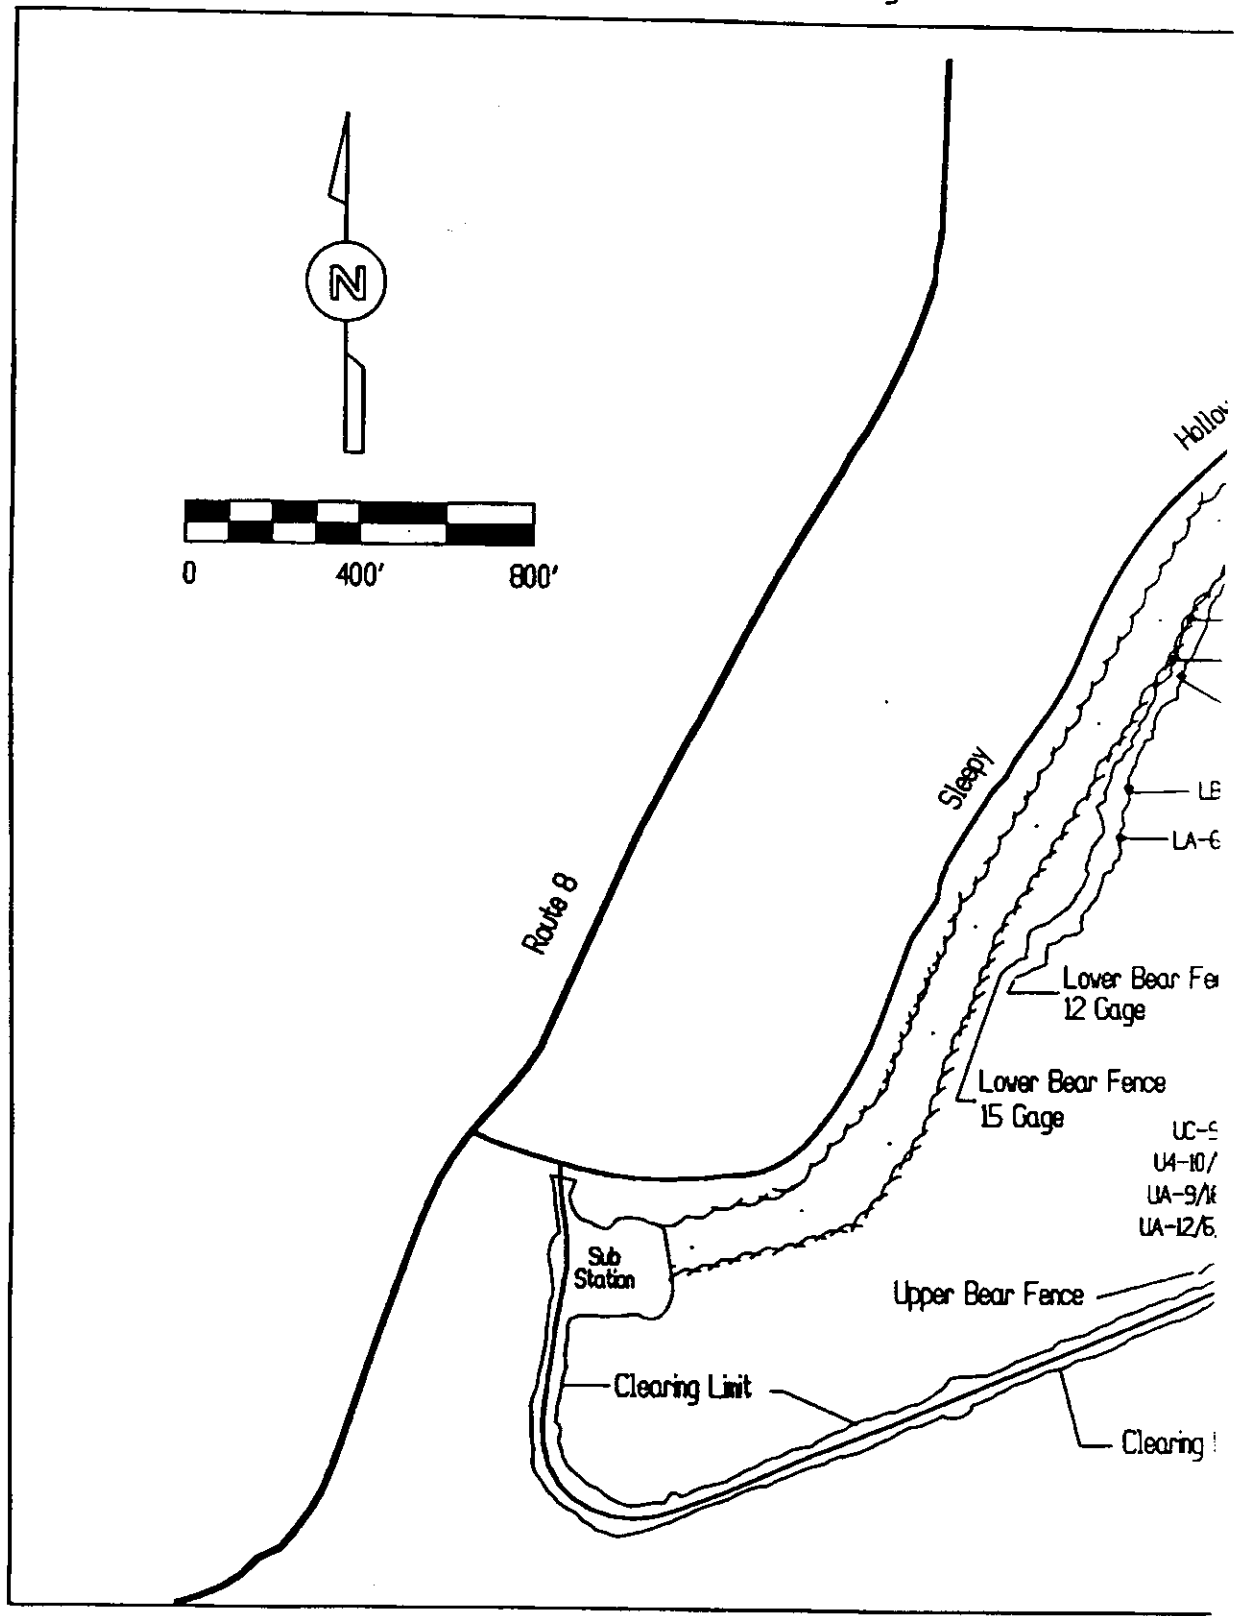
FIGURE 3 Wind Turbine Project Layout and Black Bear Fence Snag Locations

A project site plan was generated using Global Positioning System (GPS) equipment so that the fences could be shown in relationship to the wind turbine locations (Figure 3). Each snag location on

the fences was then plotted with GPS to see if the actual corridor could be defined. Regretfully, the original lower fence was removed in the spring of 1996 before the 1995 snag locations could be positioned with the GPS equipment, consequently, Figure 3 does not contain 1995 lower fence snag locations.

It was originally theorized, and now appears to be a reasonable assumption, that the bears were likely moving through the saddle between the two ridges upon which the turbines are situated. The access road intersection at the top of the ridge is in this saddle with turbines 1 through 7 on the north ridge and turbines 8 through 11 on the south ridge (see Figures 1 and 3). The clustered snags on the upper fence show a pattern developing with three main avenues of approach to the saddle between the ridges while the snags on the lower fence are more diffused.
